Basement Flooding Study

Town of Essex

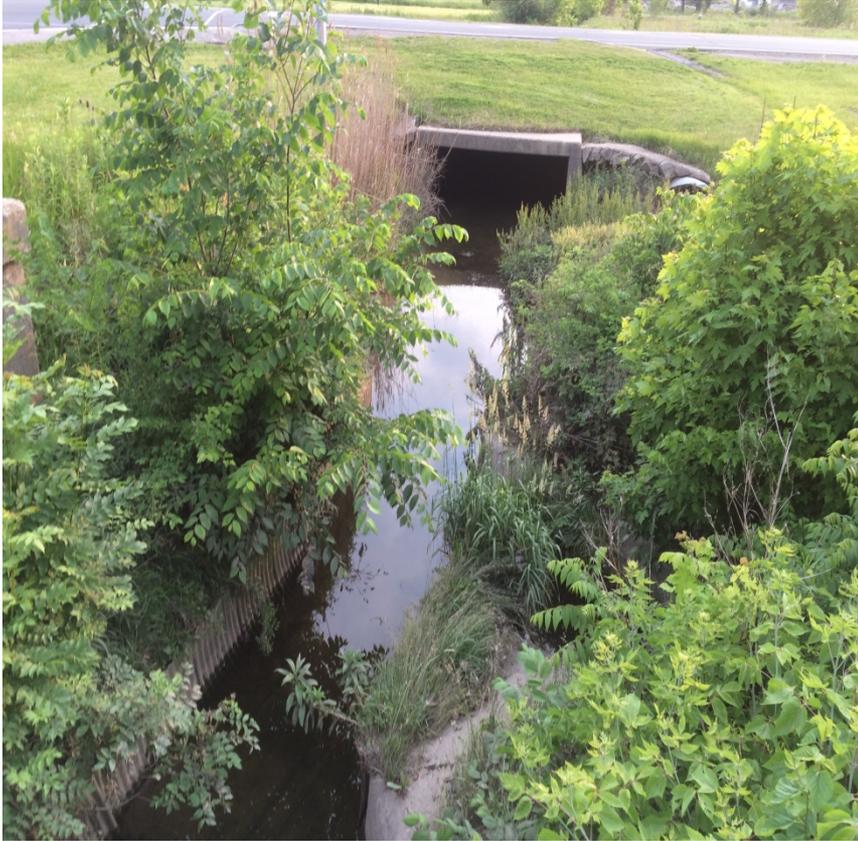
Figure 2: Essex Outlet Drain PRIOR to a small storm event (June 2015).

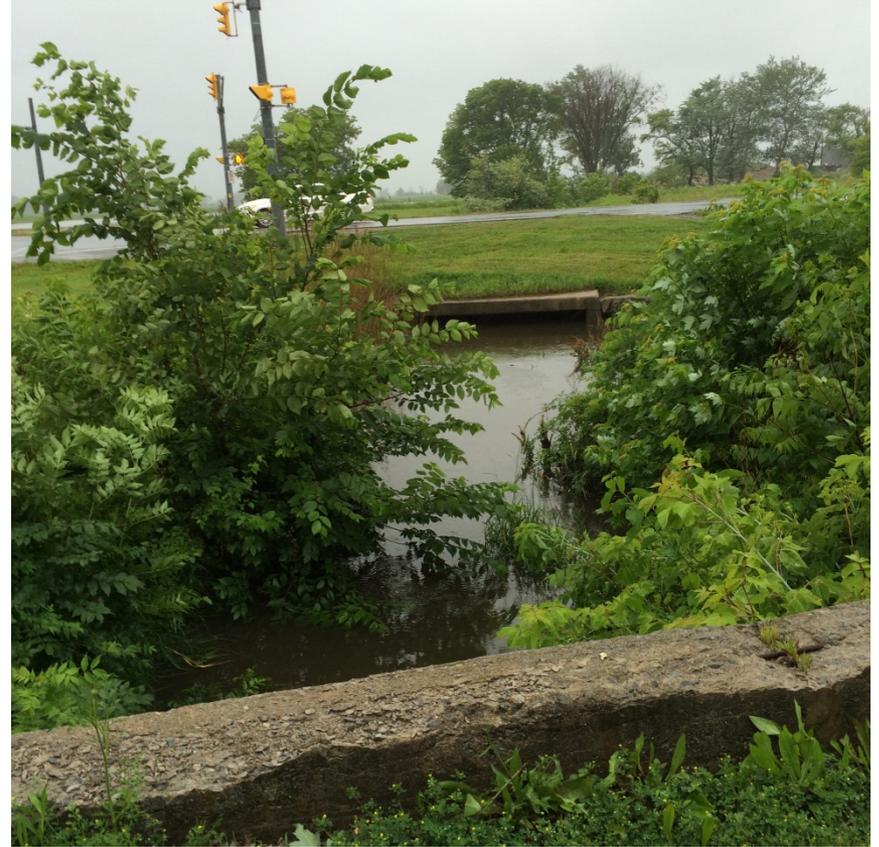
Figure 3: Essex Outlet Drain flowing full after a small storm event. Photo taken AFTER ½" of rainfall (June 2015).

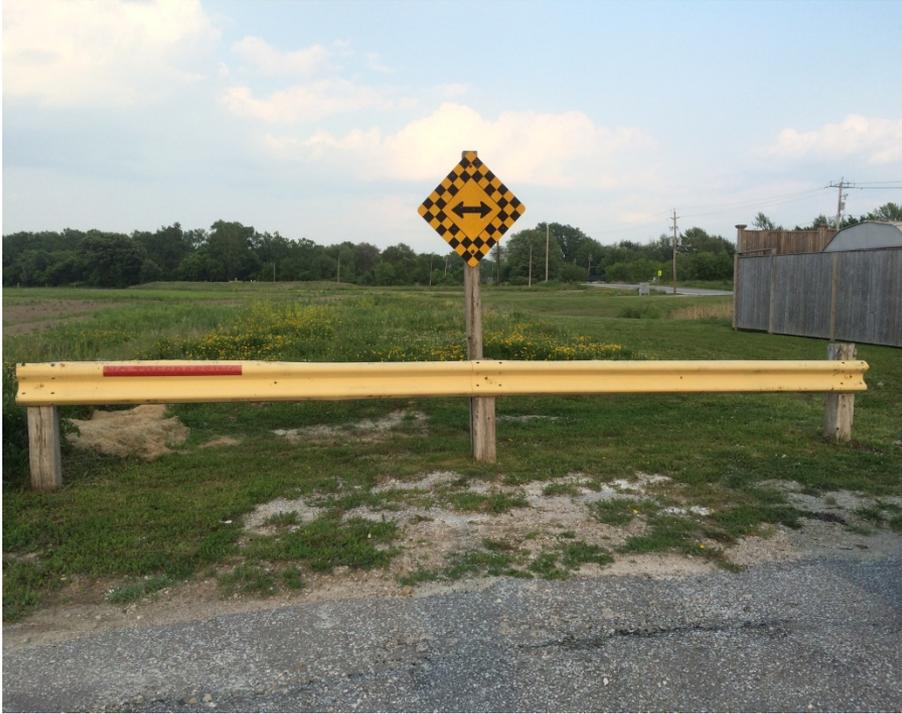
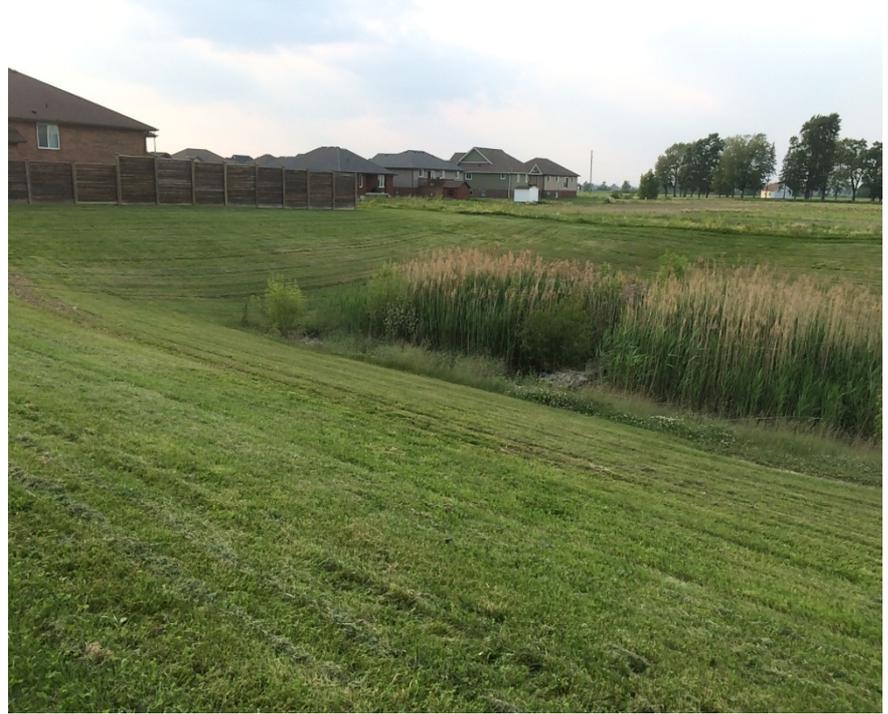
Basement flooding in Golfway and Galos Development is considered to be mainly caused by site grading

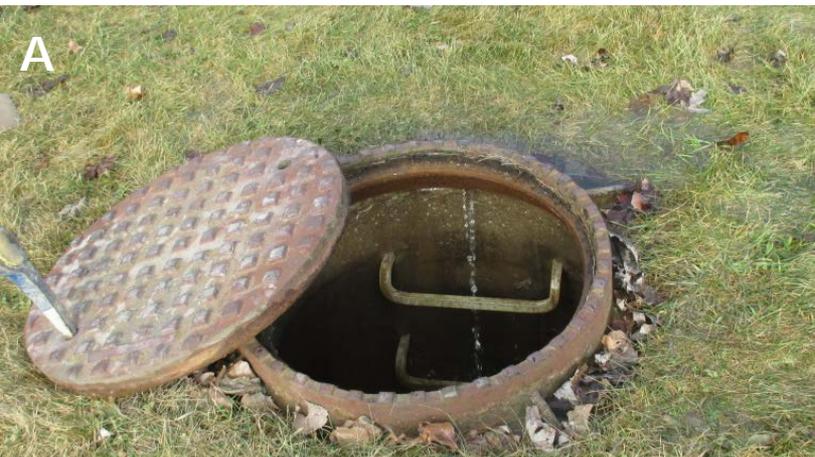
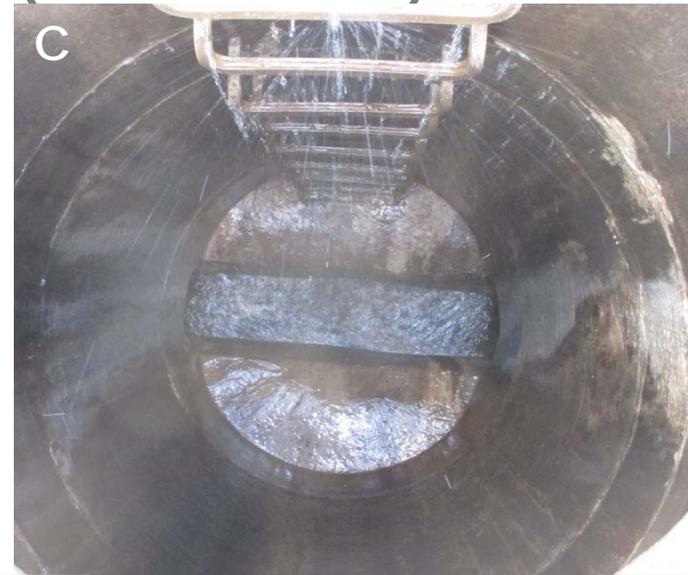
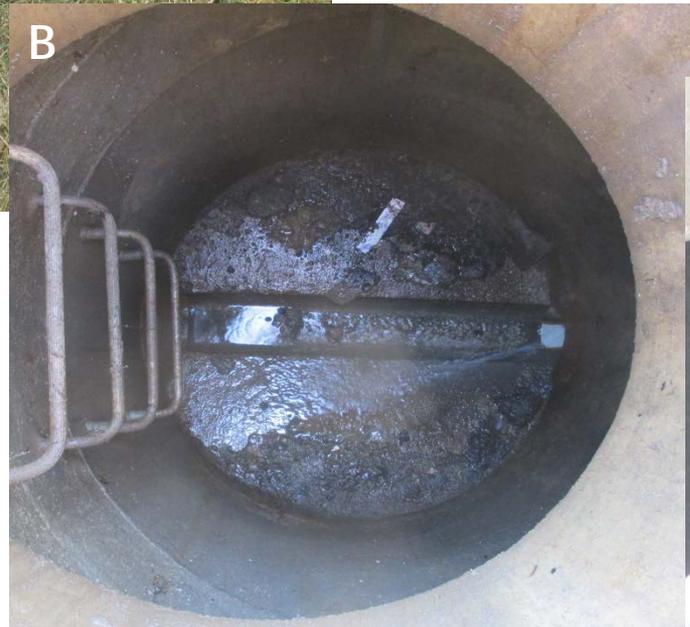
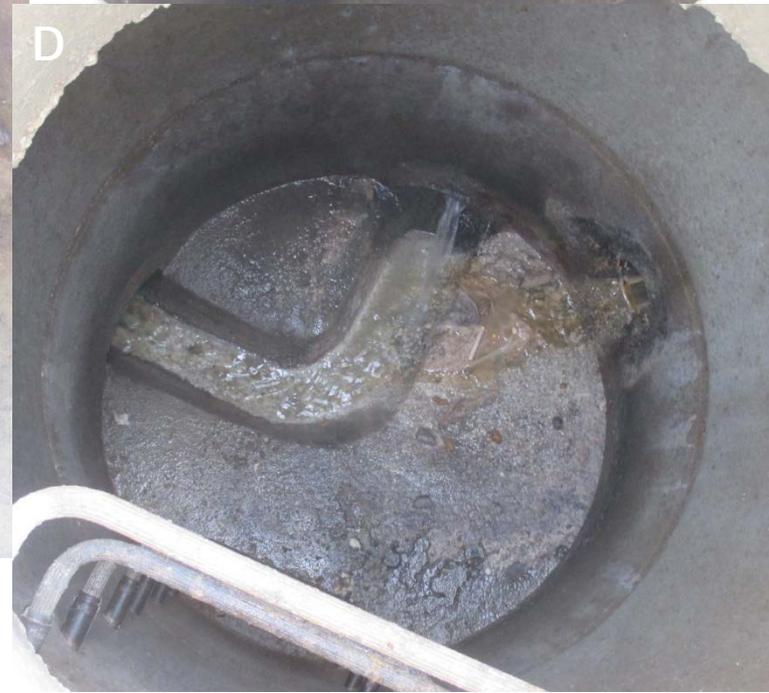
Figure 5: Inflow and infiltration entering sewer system (A, B, C, D)

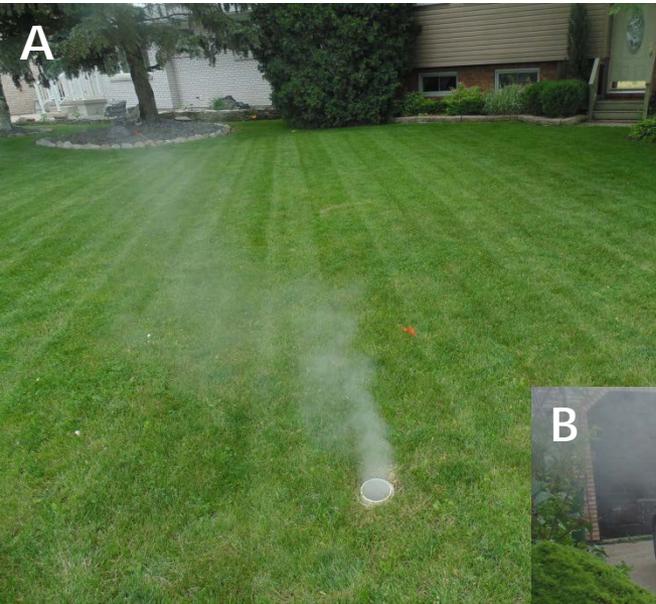
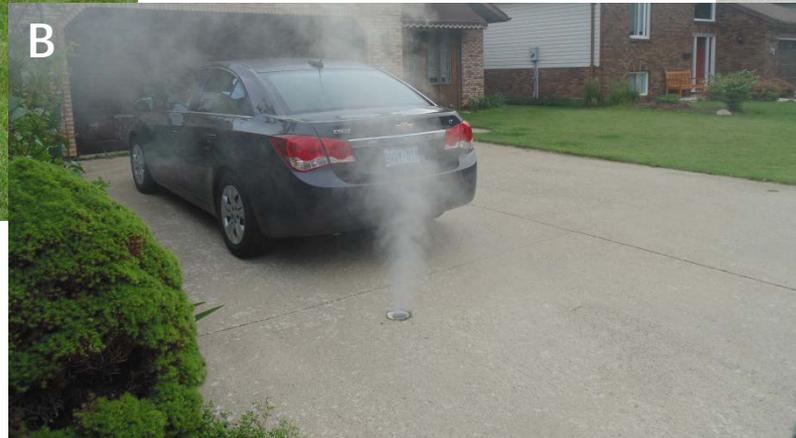
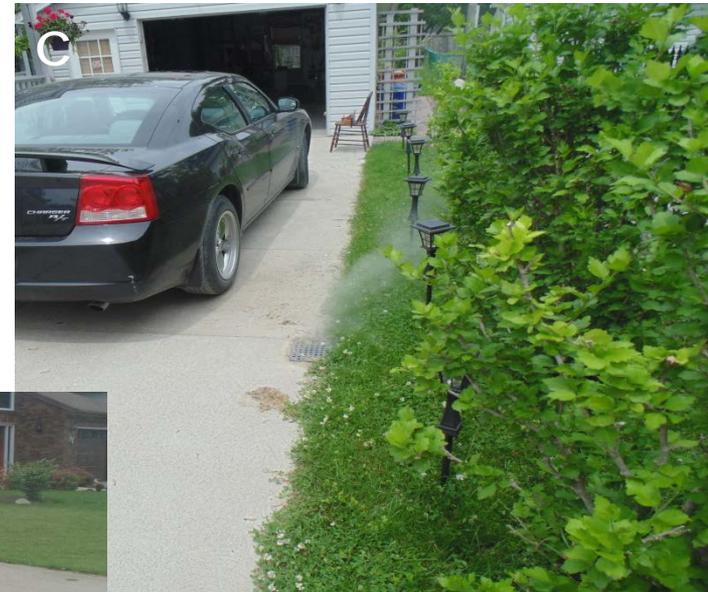
- Some storm water directly discharge into sanitary sewer, and some defects observed (mostly related to cleanout caps)

Figure 7: Heavy fog from cleanouts (A, B) and driveway drain (C)

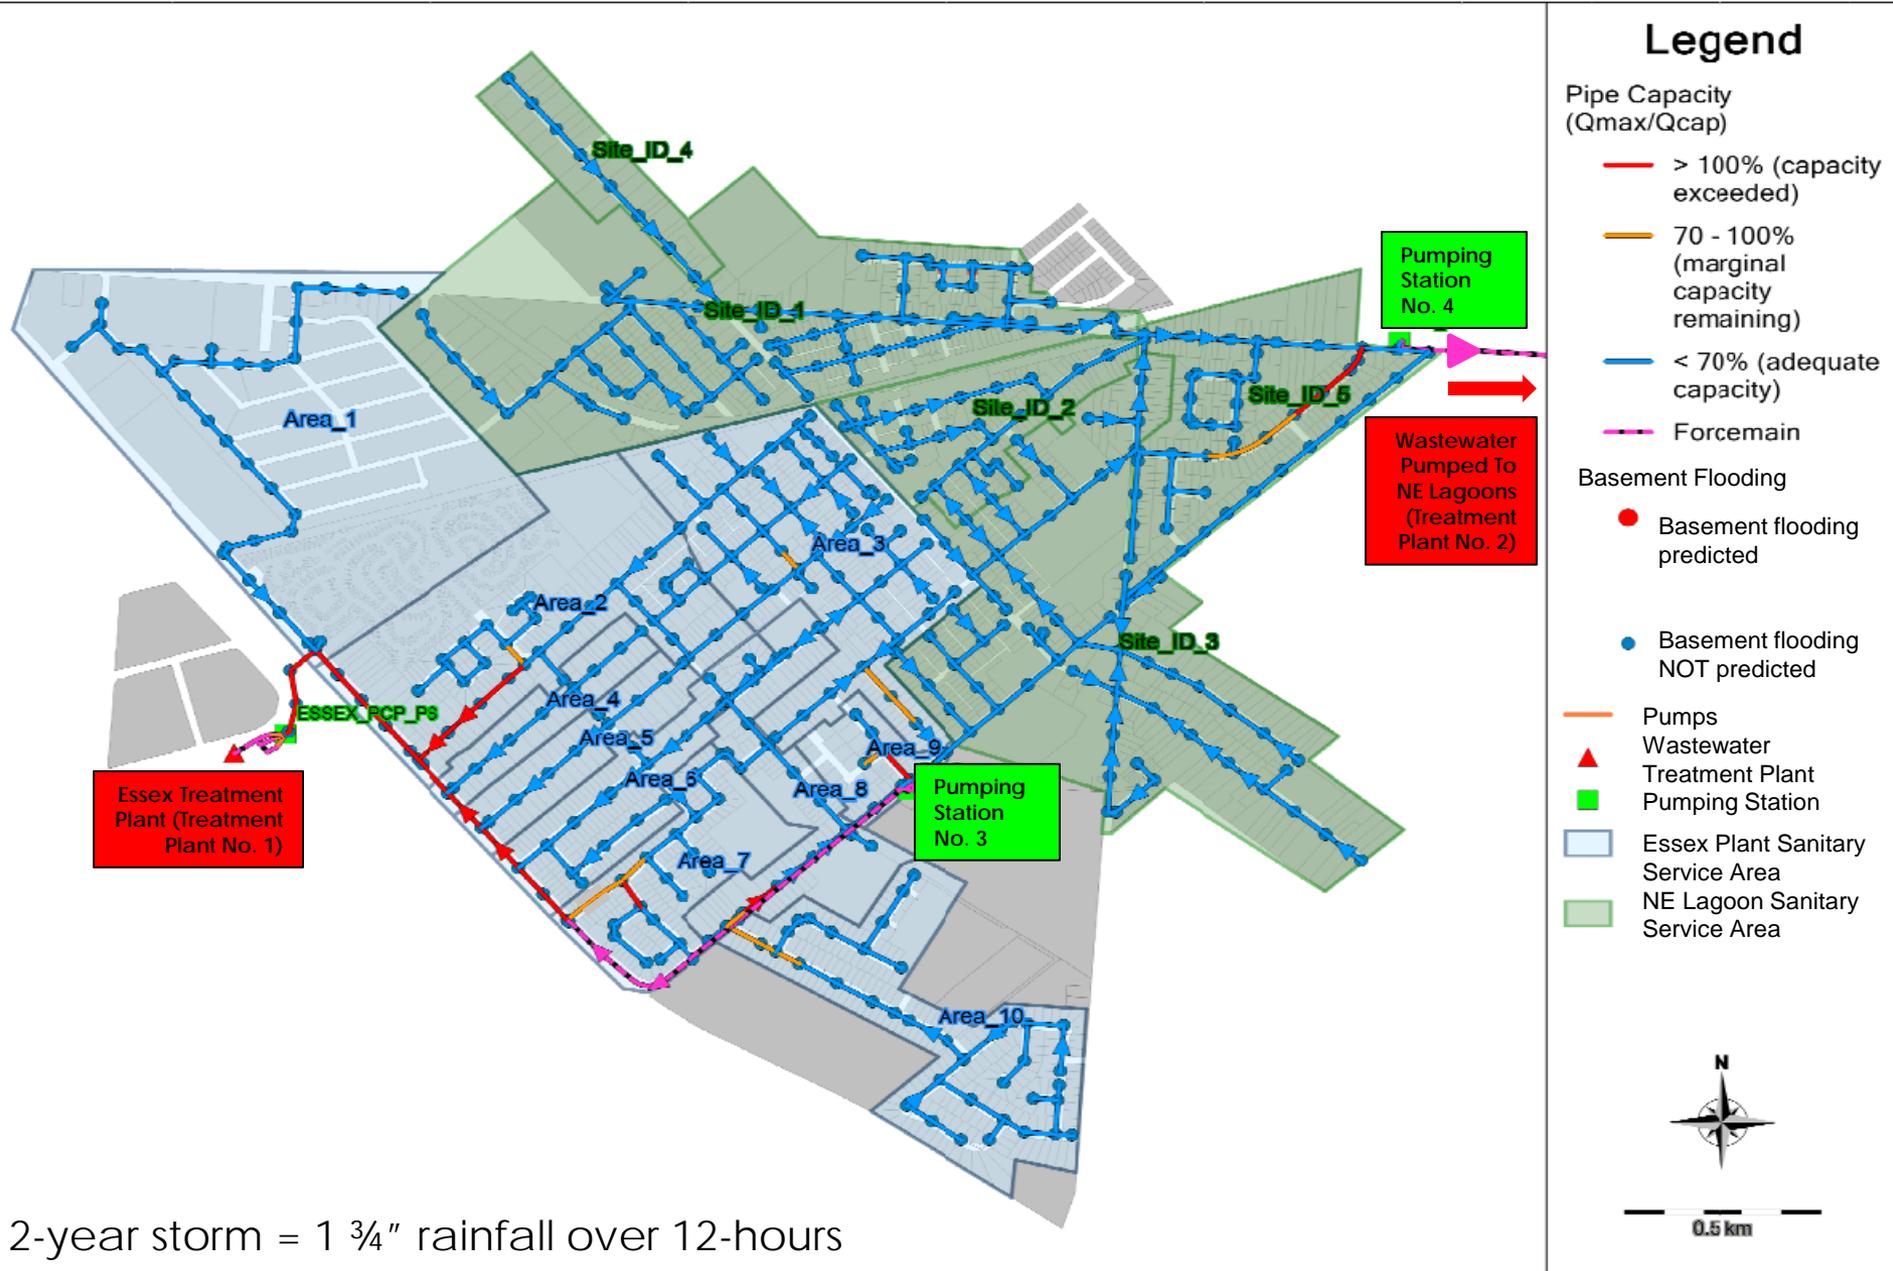
Predicted effect of 2-year storm on sanitary sewer network

- Pipe capacity limited along several portions of the network shown in next slide.

- Pipe capacity limited in the northeast portion of the sewershed.
- No basement flooding was predicted from 2-year storms.

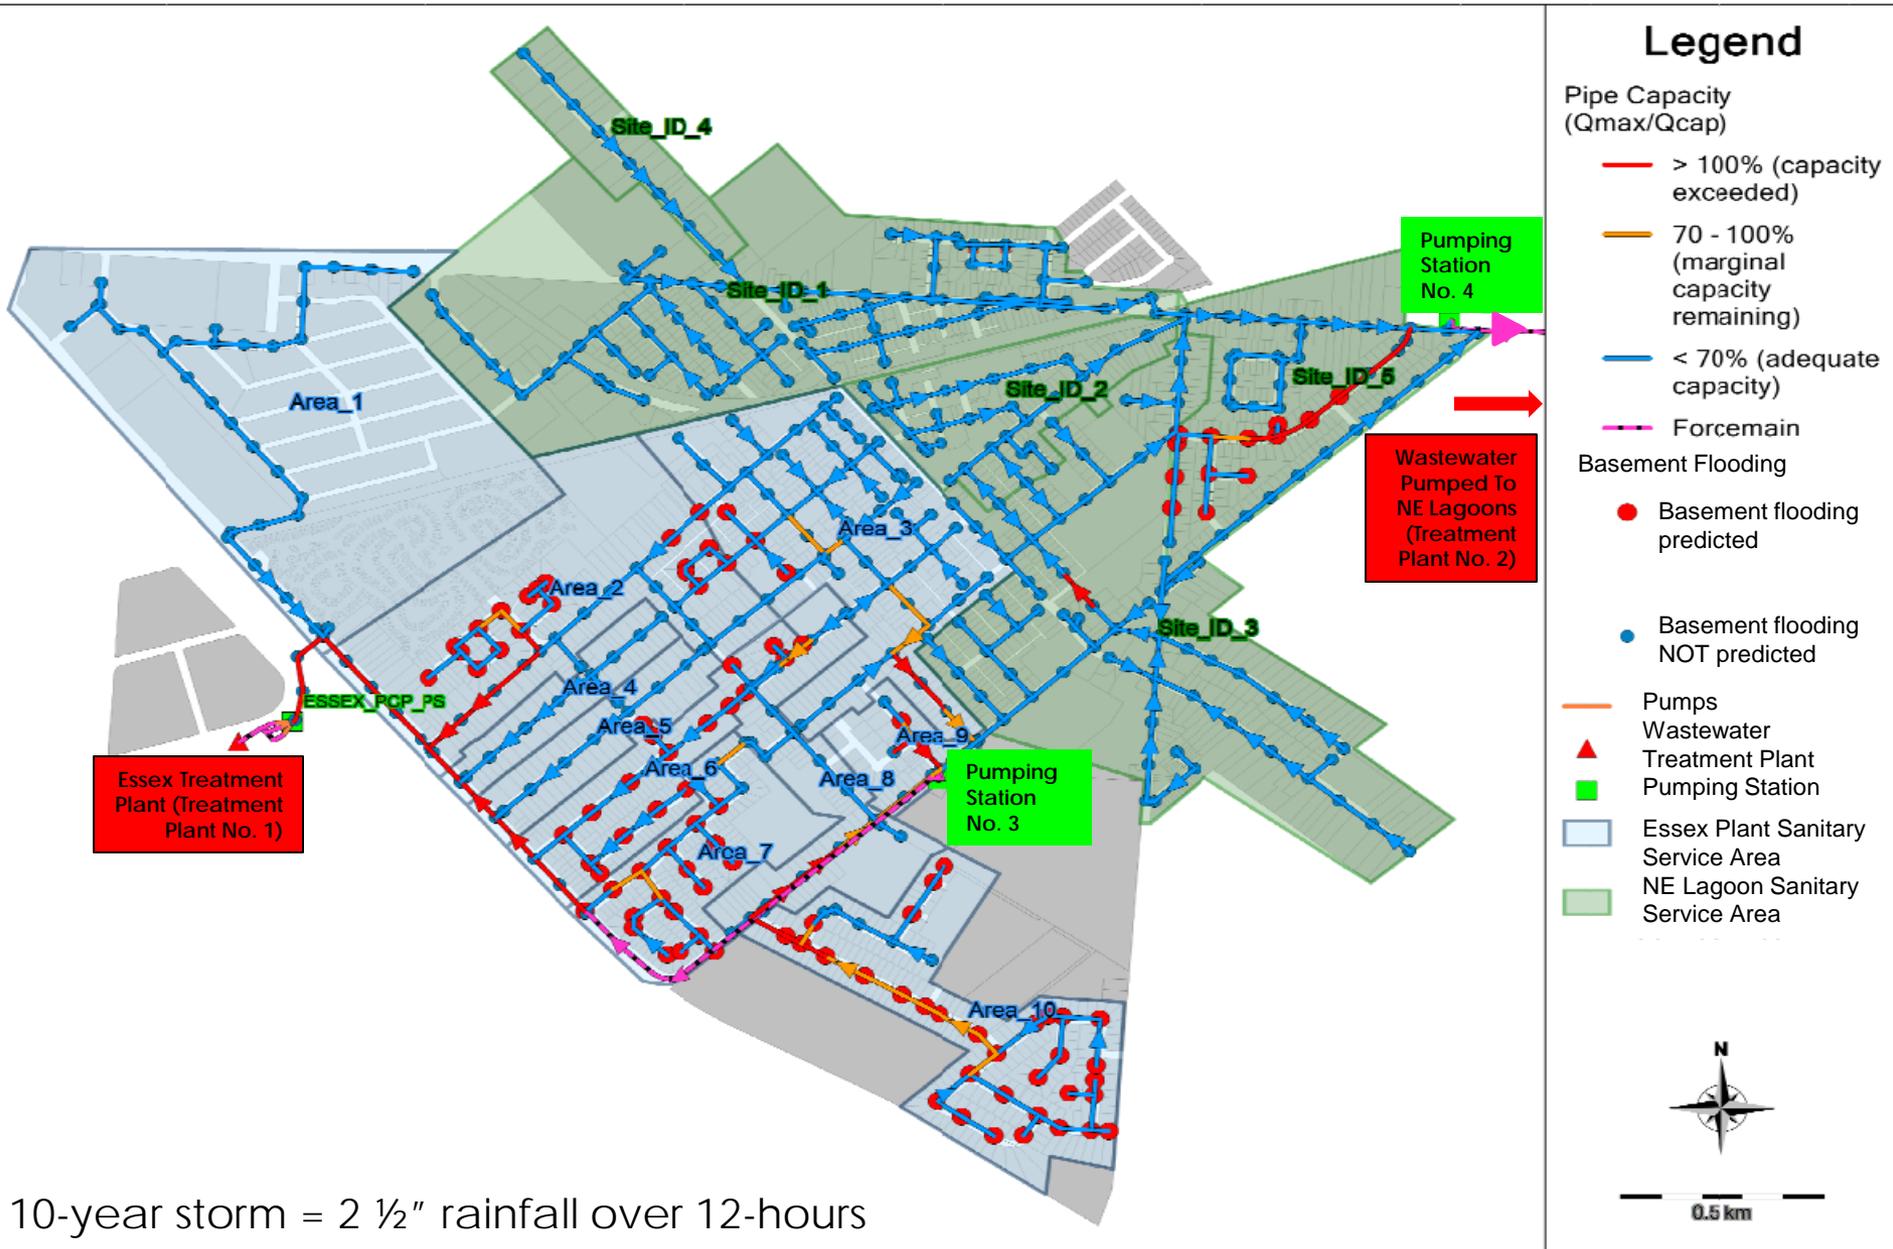
Predicted effect of 10-year storm on sanitary sewer network

- Storms equal to or exceeding 10-year return periods caused the majority of the Essex Plant service area to be surcharged.
- Basement flooding occurred in several portions of the network shown in next slide.

- Pipe capacity further limited in the northeast portion of the sewershed.
- Basement flooding was also prevalent in this subdivision.
