Basement Flooding Study

Town of Essex

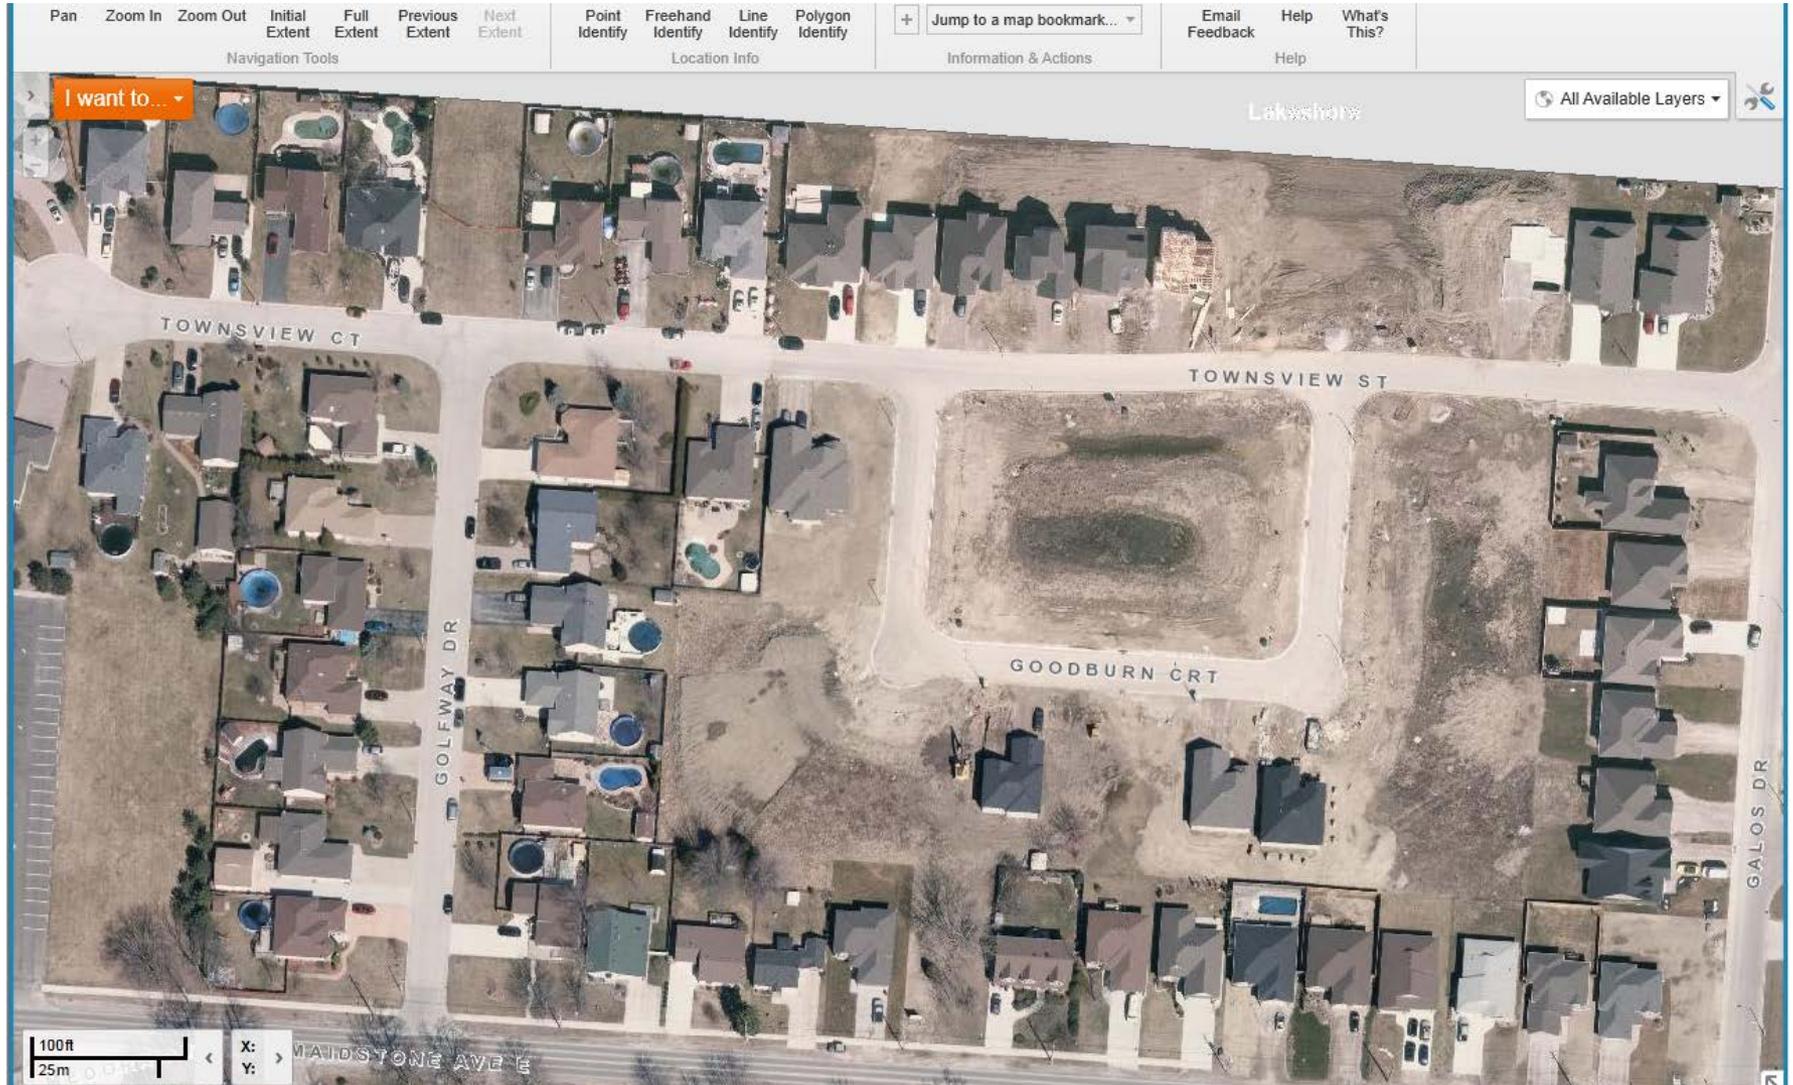
Site Grading – Golfway and Galos Developments

Basement flooding in Golfway and Galos Development is considered to be mainly caused by site grading

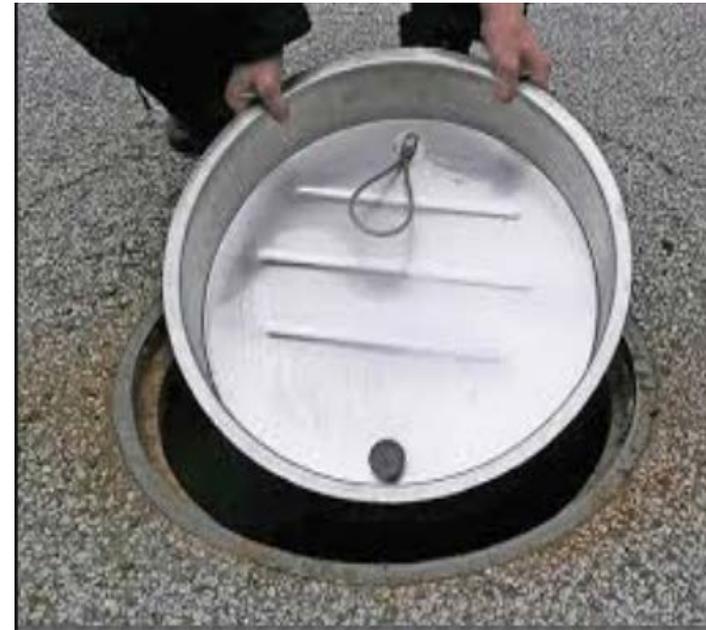
Results: Engineer

- Majority of manholes were in acceptable condition
- Some manholes were found to require repair/rehabilitation
